LINCOLN PARK IN JERSEY CITY: MASTER PLAN FOR THE BELMONT AVENUE ENTRANCE

JULY 2023

SITE AND LANDSCAPE FEATURES EXISTING CONDITIONS

ARCHITECTURAL FEATURES EXISTING CONDITIONS

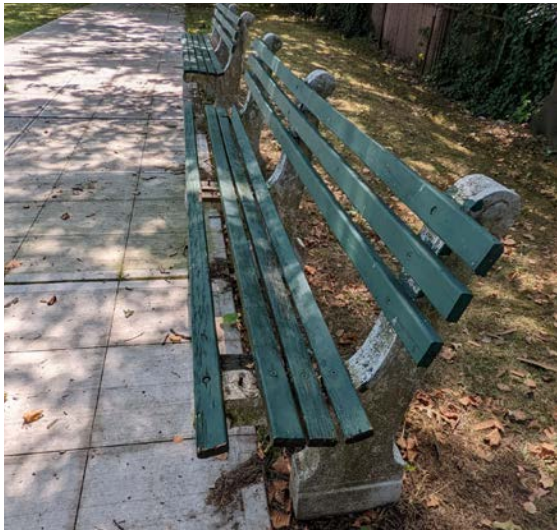
1. Damaged concrete and wood slat bench

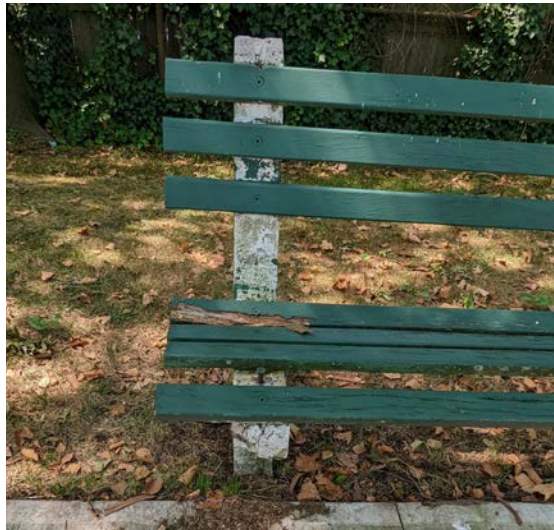
1. Damaged concrete and wood slat bench

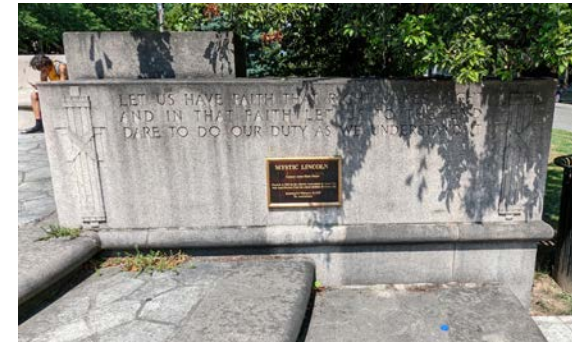
3. Low granite wall with text and art deco carvings; note staining

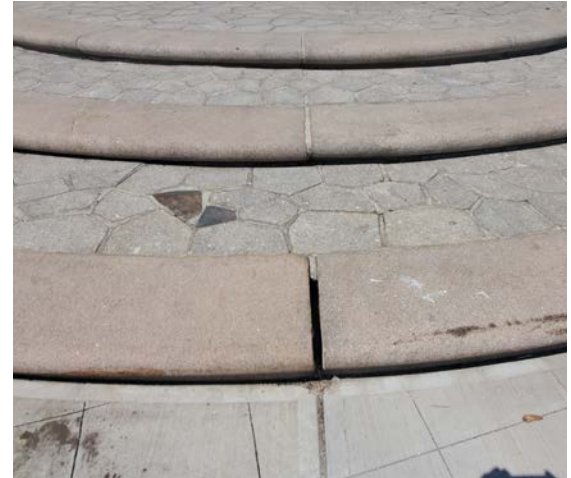
6. Typical condition of steps and paving

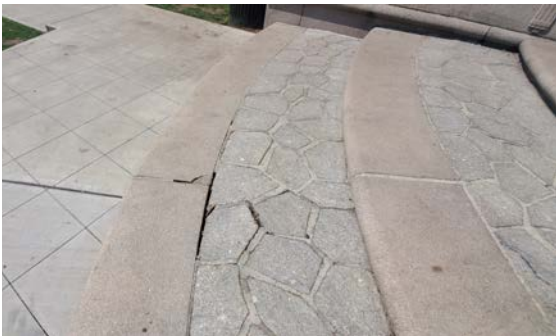
7. Typical condition of steps and paving

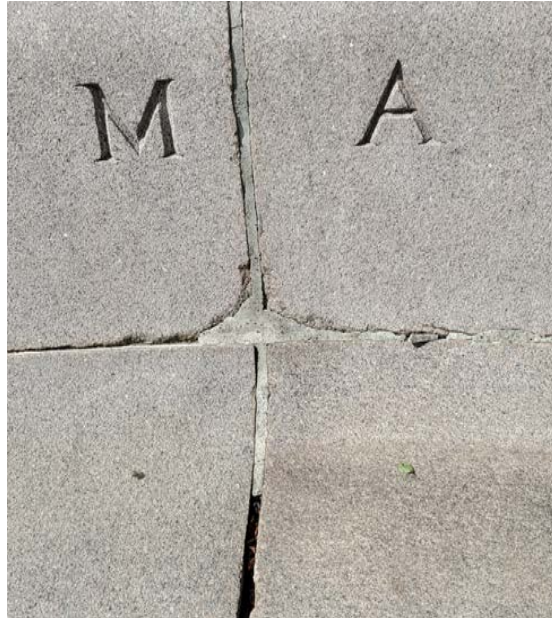
8. Closeup of paving showing need for careful repointing

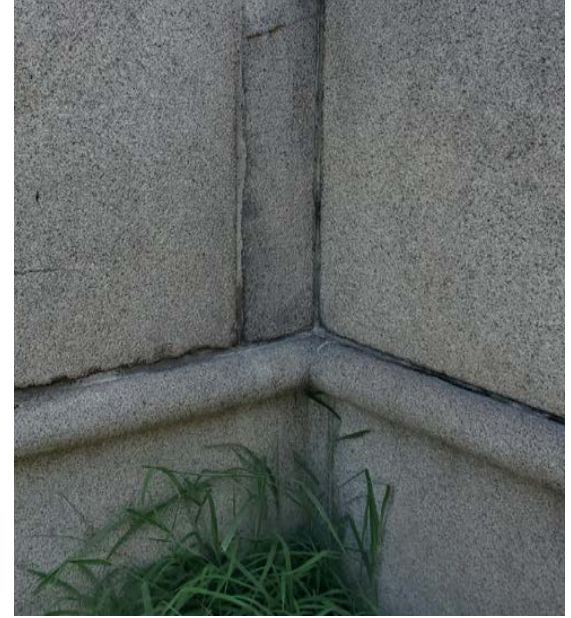
9. Detail of wall at rear of statue; typical condition of mortar joints

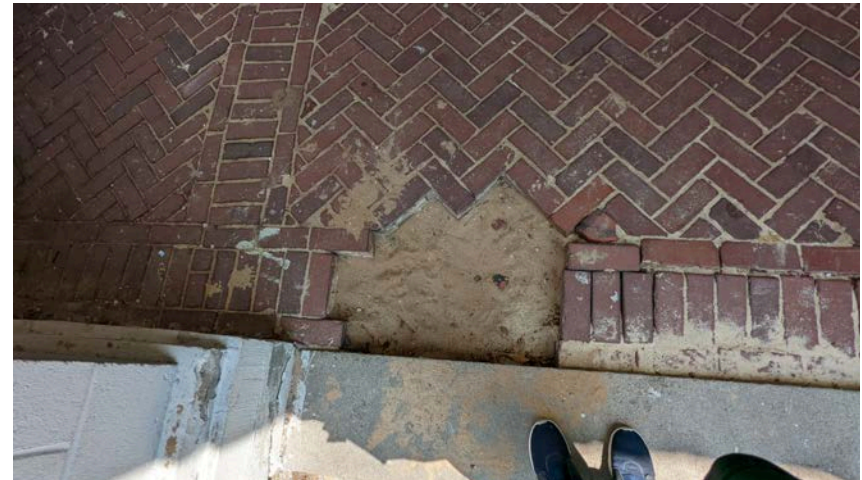
13. Missing brick at interior floor

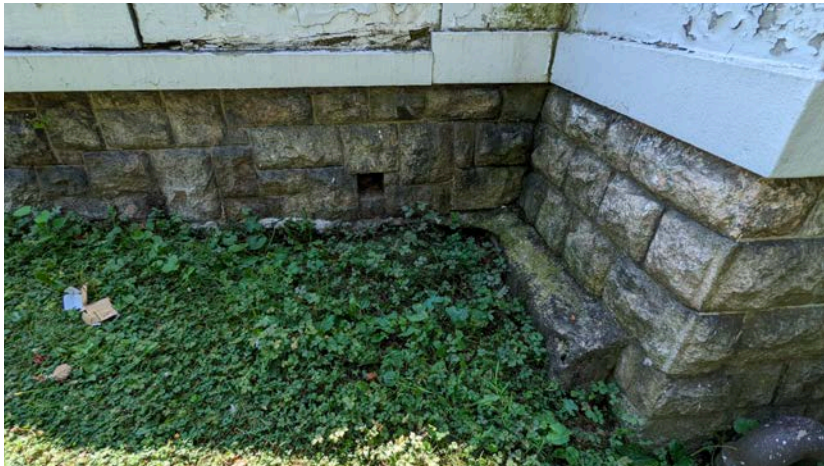
15. Fieldstone base showing soiling and missing pointing

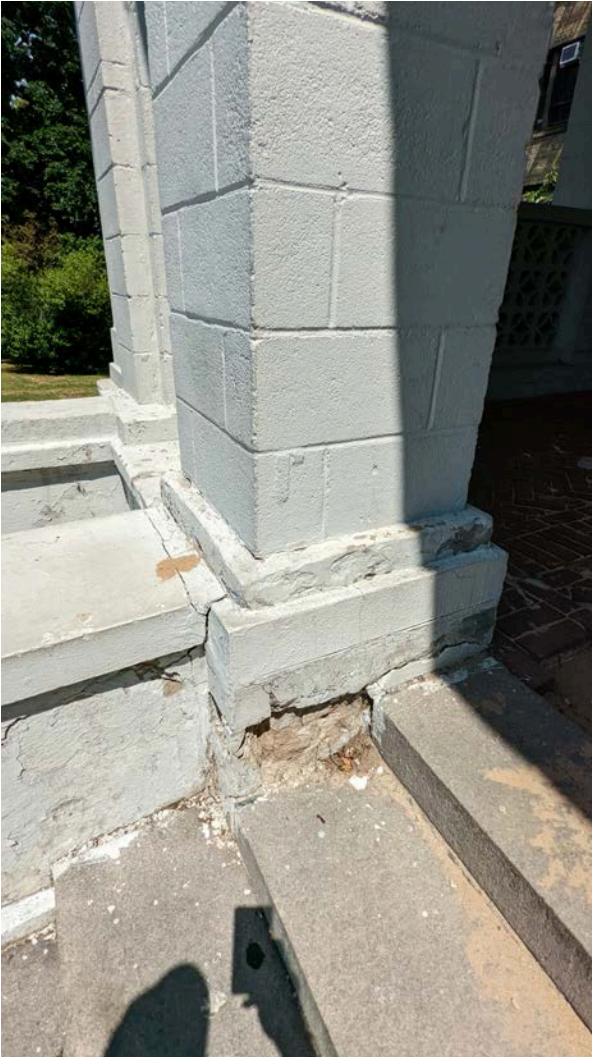
17. Spalling at original stone base of replaced column

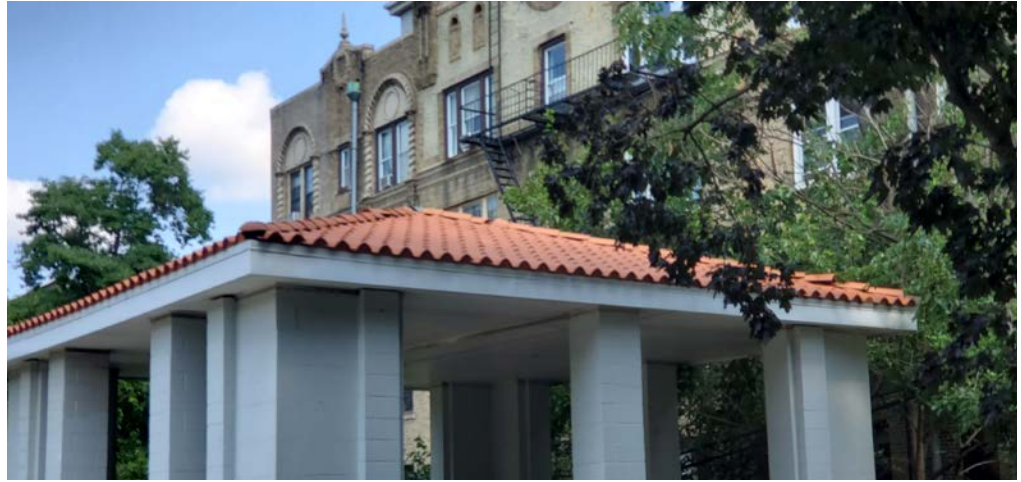
Terra Cotta Roof	10, 18	Curved terra cotta tiles	Likely replacement of original terra cotta tiles	Good; several damaged and dislocated tiles	Yes	Continue to maintain. Replace missing and damaged tiles to match existing.
Ceiling	10, 11, 16	Painted wood board ceiling	Likely c. 1970 replacement	Good	Yes	Likely similar to original design; maintain.
Low Walls at Terrace and Steps	10, 14, 15, 17, 19	Painted concrete, decorative terra cotta and CMU	Original and c. 1970	Poor; severe freeze thaw damage	Yes	Repair if possible; if infeasible, remove and reconstruct walls to match original design
Steps	14, 17	Concrete steps	Likely c. 1970	Fair to Good	Yes	Repair and maintain

18. Terra cotta roof; several tiles are missing

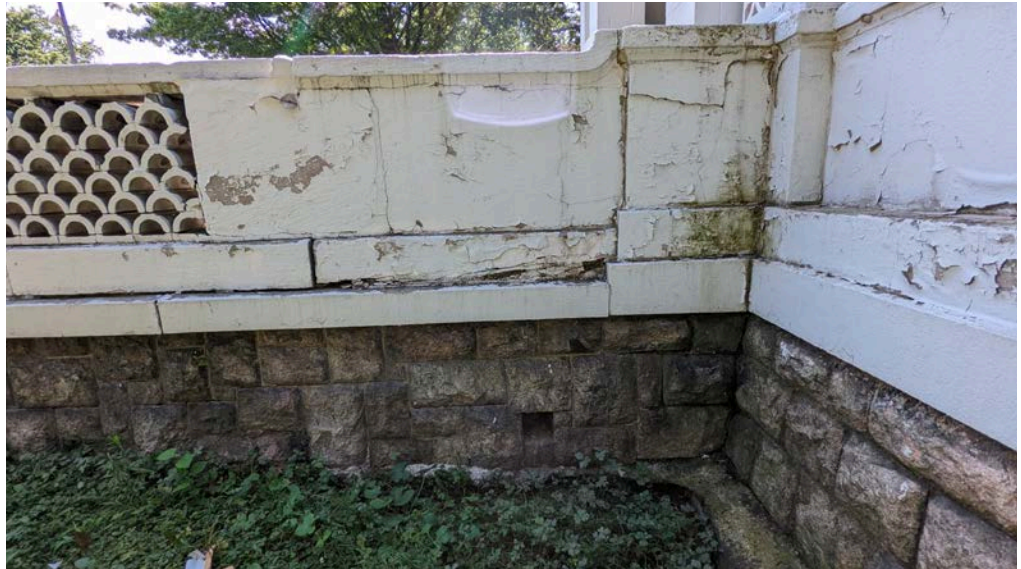
19. Fieldston base and damaged concrete and terra cotta wall

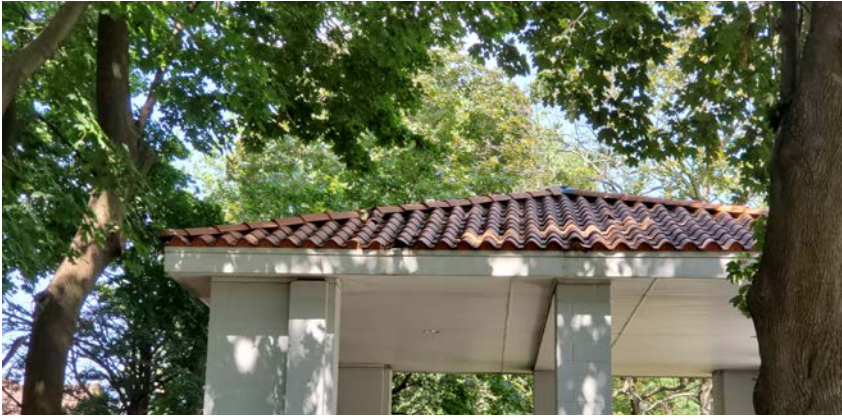
Terra Cotta Roof	22, 24	Curved terra cotta tiles	Likely replacement of original terra cotta tiles	Good; several damaged and dislocated tiles	Yes	Continue to maintain. Replace missing and damaged tiles to match
Ceiling	23, 27	Painted wood board ceiling	Likely c. 1970 replacement	Good	Yes	Likely similar to original design; maintain.
Low Walls at Terrace and Steps	22, 28, 29, 30	Painted concrete, decorative terra cotta and CMU	Original and c. 1970	Poor to Fair	Yes	Repair if possible; if infeasible, remove and reconstruct walls to match original design
Steps	20, 25	Concrete steps	Likely c. 1970	Fair to Good	Yes	Repair and maintain

24. Terra cotta roof is missing several tiles but is in overall good condition

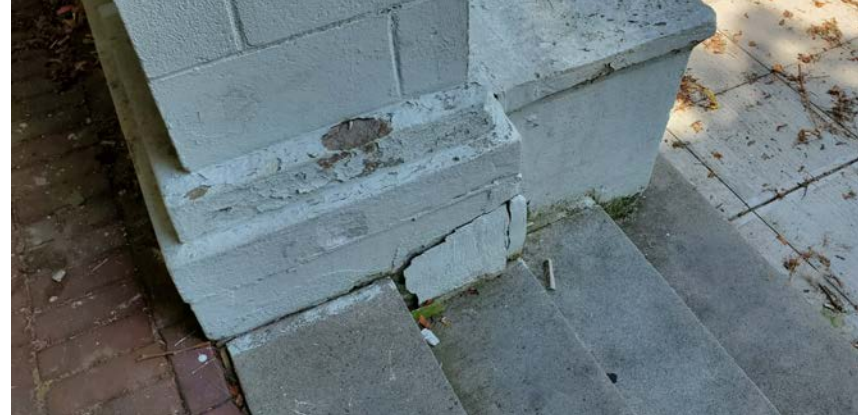
25. Freeze thaw damage at original stone base

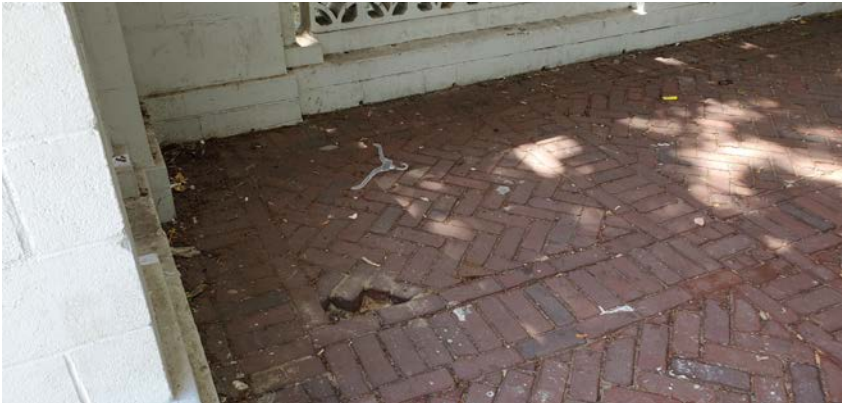
26. Brick floor with several missing pavers

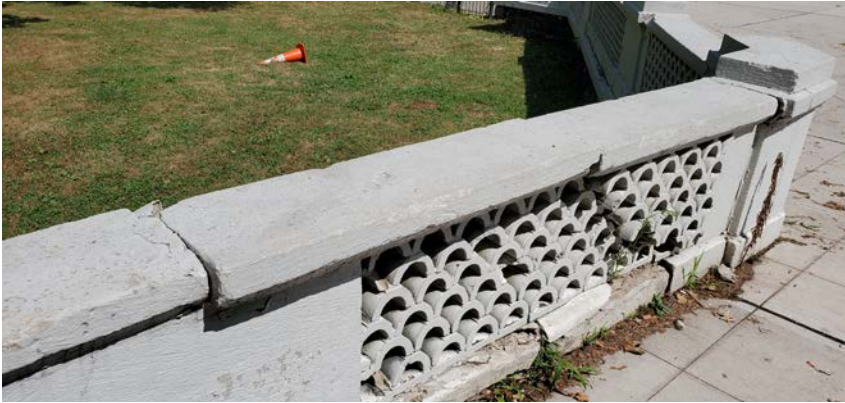
28. Severely damaged terra cotta and masonry walls

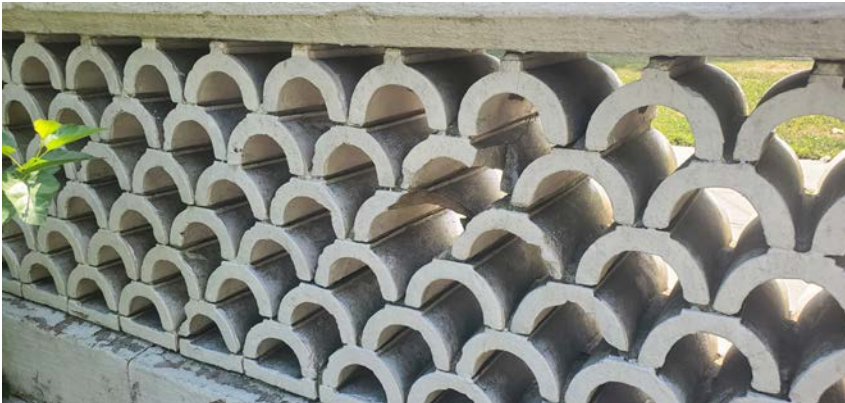
29. Detail of damage to the existing walls (decorative arches are painted terra cotta)

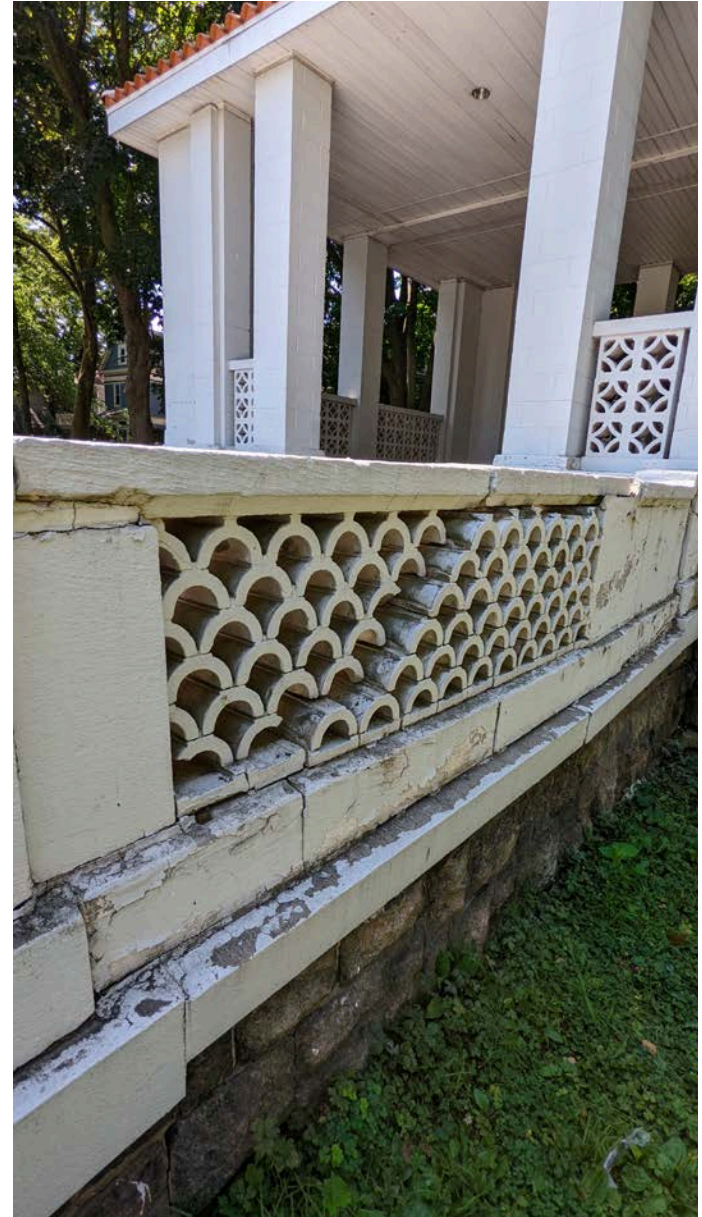
30. Detail of damage at the existing walls

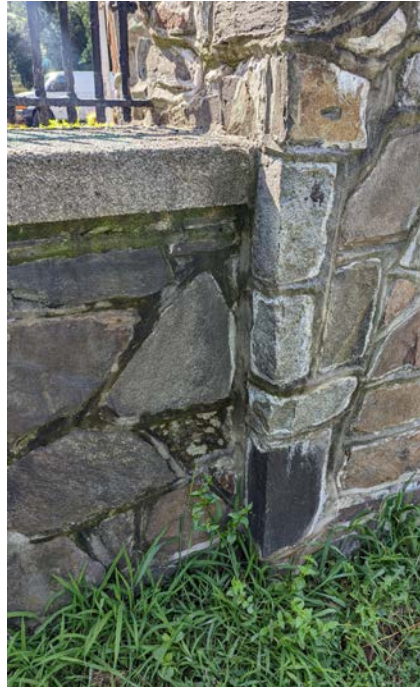
35. Detail showing different pointing campaigns with biological growth and damaged pointing

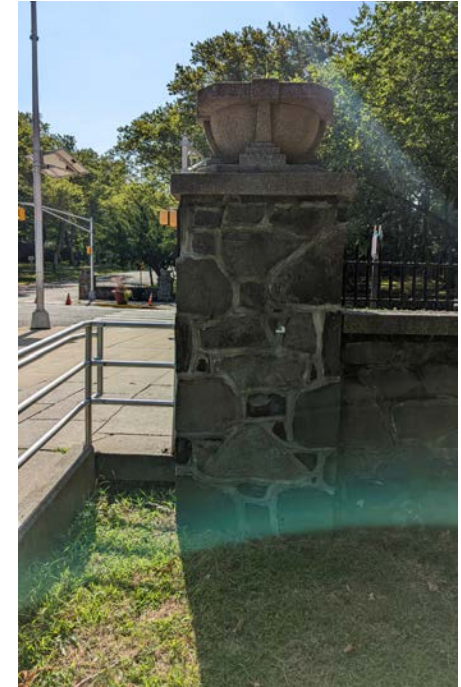
36. Pier with historically incompatible railing adjacent

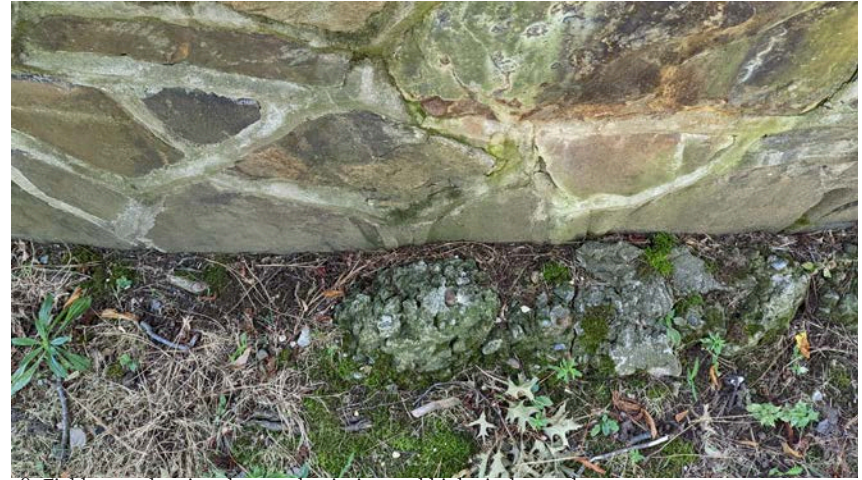
38. Fieldstone showing damaged pointing and biological growth staining

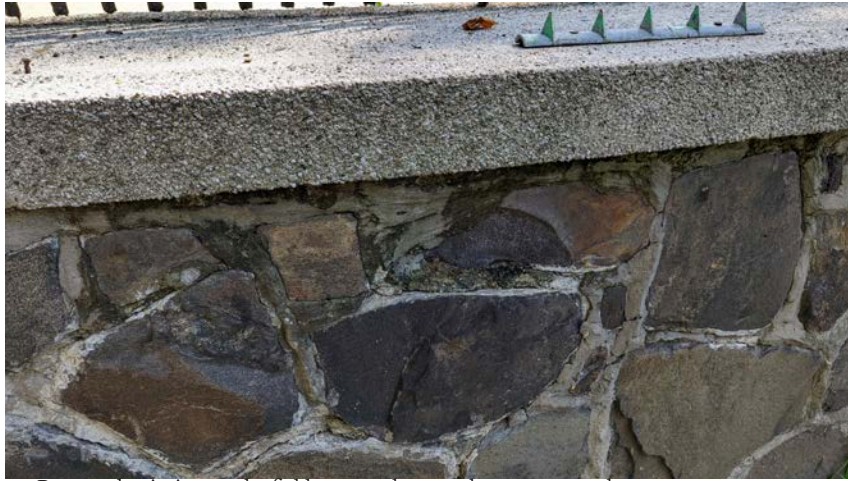
43. Damaged pointing on the fieldstone and exposed aggregate on the cast stone cap

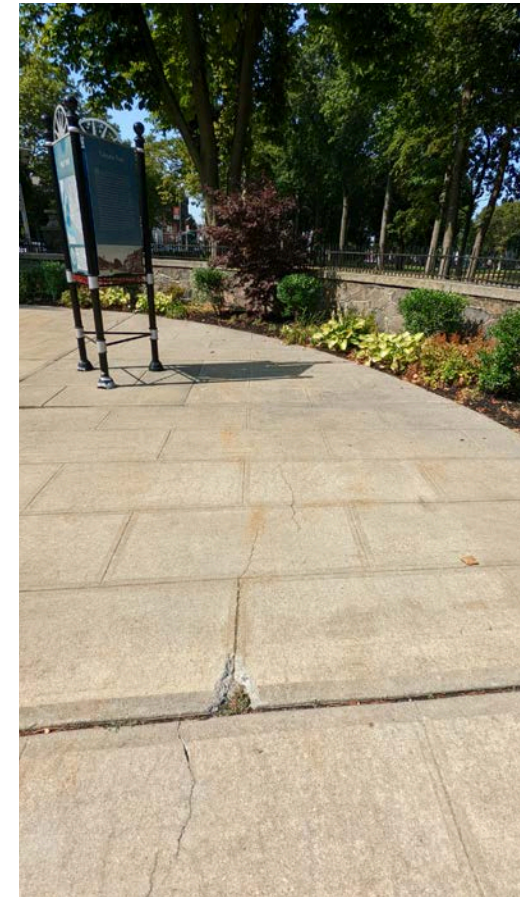
Minor concrete cracking in sidewalk
