LINCOLN PARK IN JERSEY CITY: MASTER PLAN FOR THE BELMONT AVENUE ENTRANCE

JULY 2023

SITE AND LANDSCAPE FEATURES EXISTING CONDITIONS

ARCHITECTURAL FEATURES EXISTING CONDITIONS

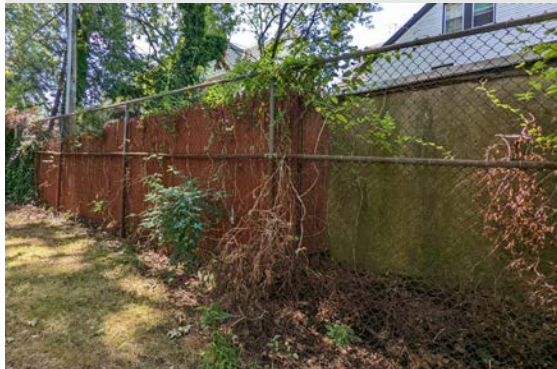
1. Site Fencing (Chain Link Perimeter)

Fencing and Signage						
Feature	Photos	Description	Period	Condition	CDF	Recommendation
Site Fencing (Chain Link)	1	Perimeter galvanized chain-link fence	After period of significance	Poor	No	Replace all galvanized fencing with vinyl coated chain link at the perimeter or historically appropriate ornamental steel at the interior.
Site Fencing (Ornamental Steel - Traditional)	2	Custom painted steel bar fencing	During Period of Significance	Fair to Good	Yes	Maintain, repair, clean and refinish
Site Fencing (Ornamental Steel - Modern)	3	Manufactured powder coated aluminum fencing	After period of significance	Poor to Fair	No	Remove, replace with historically appropriate ornamental steel fencing
Site Fencing (Wrought Iron)	4	Original wrought iron fencing and wall toppers	Original	Poor to Fair	Yes	Maintain, repair, clean and refinish
Signage (Interpretive)	5	Decorative historic interpretive signage	After period of significance	Fair to Good	No	Maintain, repair or replace information panels due to fading or damage as required.

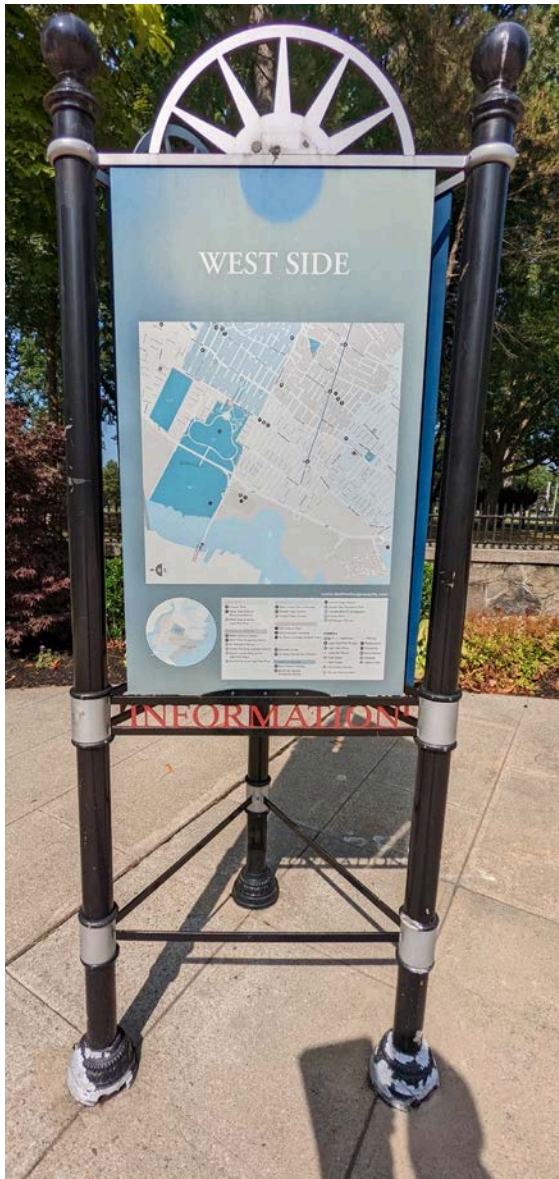
6. Wayfinding Sign

Signage (Wayfinding/Traffic)	6	Ad hoc signage throughout the park. signs attached to signs.	After period of significance	Fair to Good	No	Develop a new signage/wayfinding scheme to unify all traffic and directional signs with in the park.
Signage (Rules/Regulations)	7	Standard traffic signs with park rules and regulations at several points near park entries	After period of significance	Fair to Good	No	Identify duplicative signage and combine signs to reduce the quantity if appropriate. Integrate with wayfinding design package.

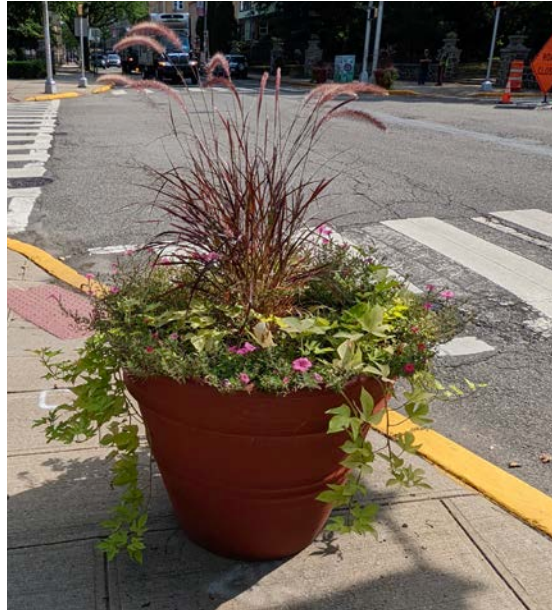
4. Fiberglass Planters

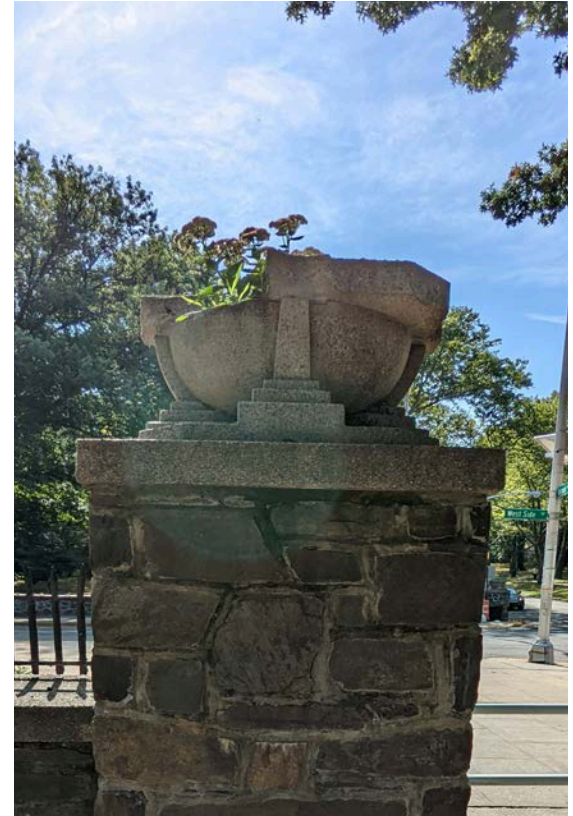
Planters (Concrete)	5	Original exposed aggregate planters urns on walls.	Original	Fair to Good	Yes	Clean, Repair, or Replace any dirty and damaged concrete urns as required

5. Concrete Planters on Wall

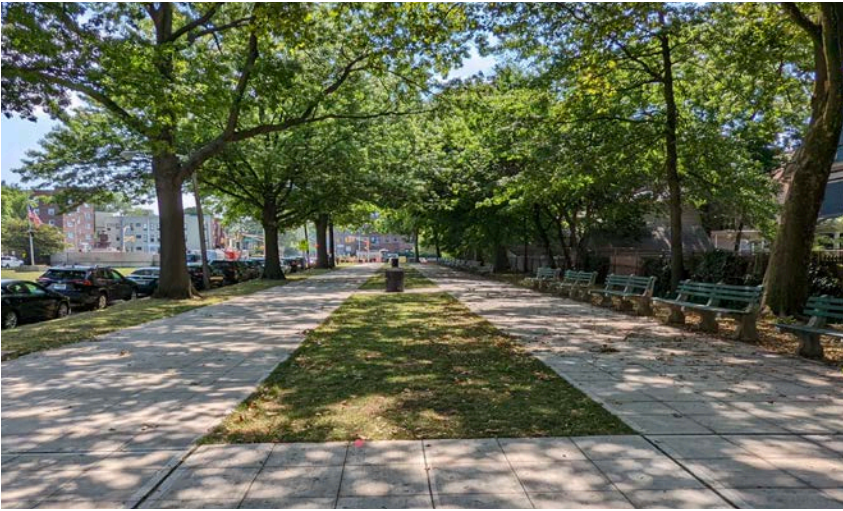
2. Planting Beds between walkways

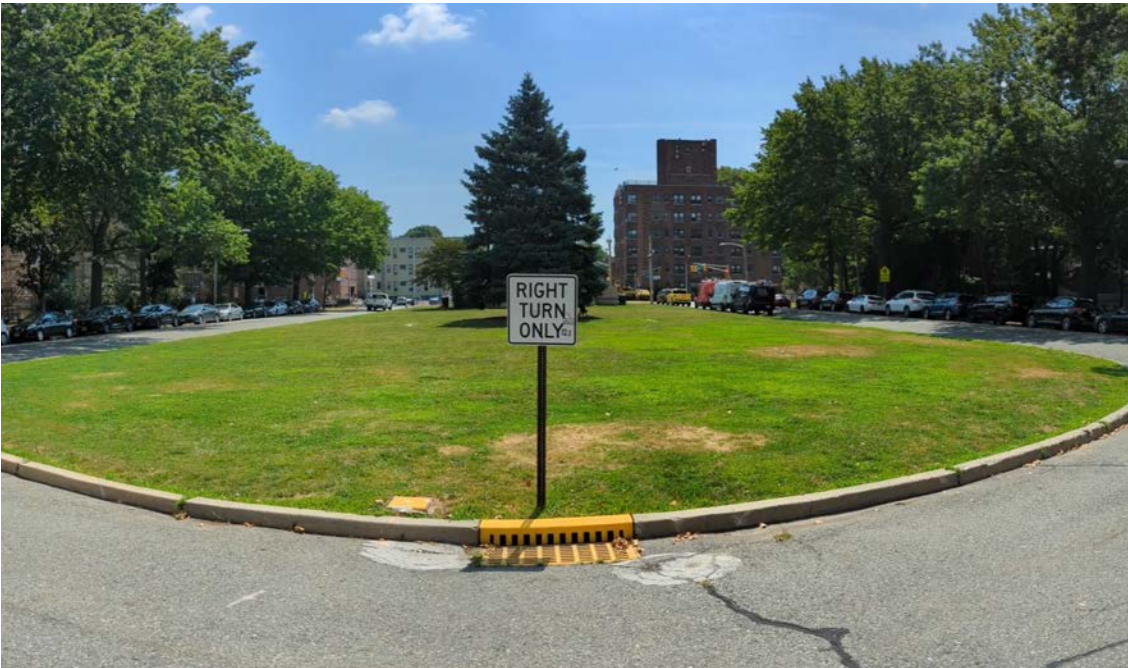
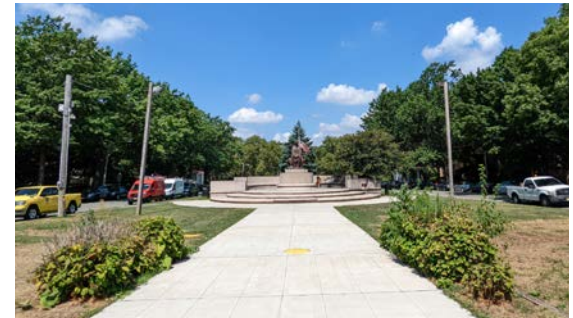
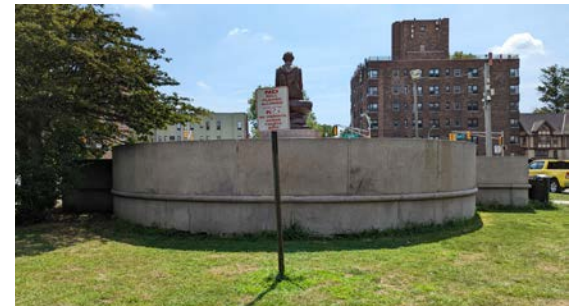
3. Area for reintroducing ornamental plantings

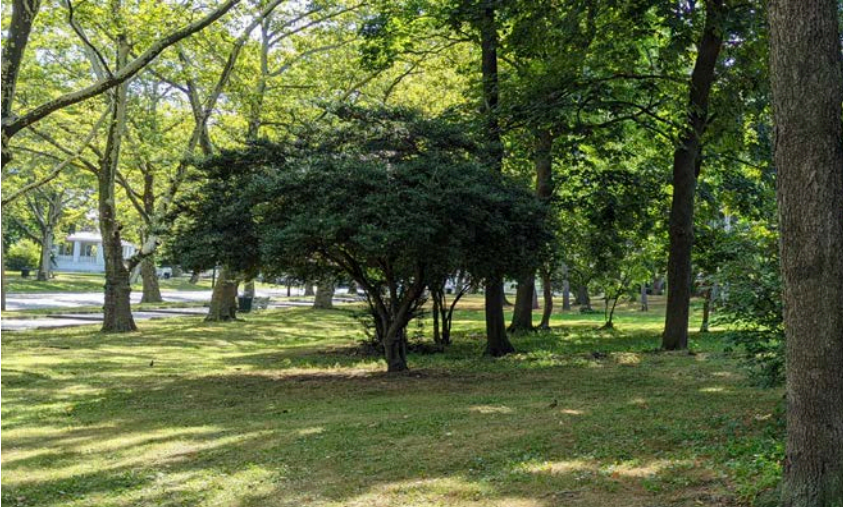
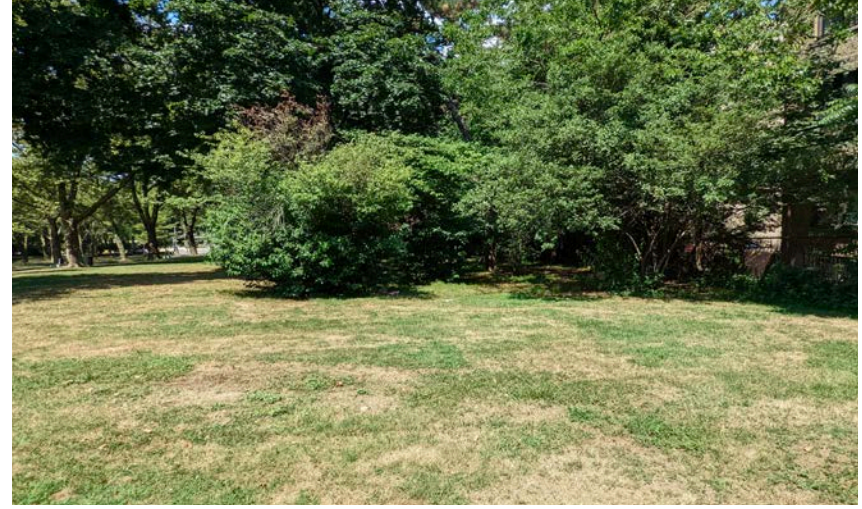
4. Understory Plantings

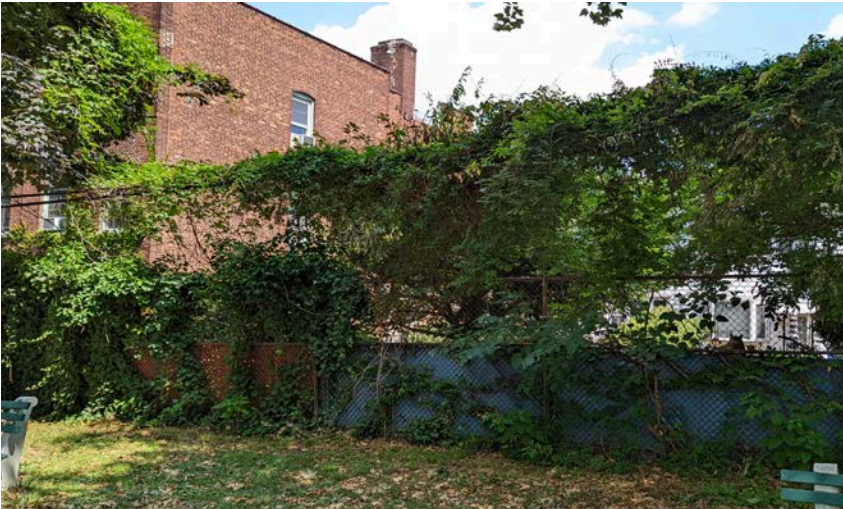
5. Planting Overgrowth on utility lines

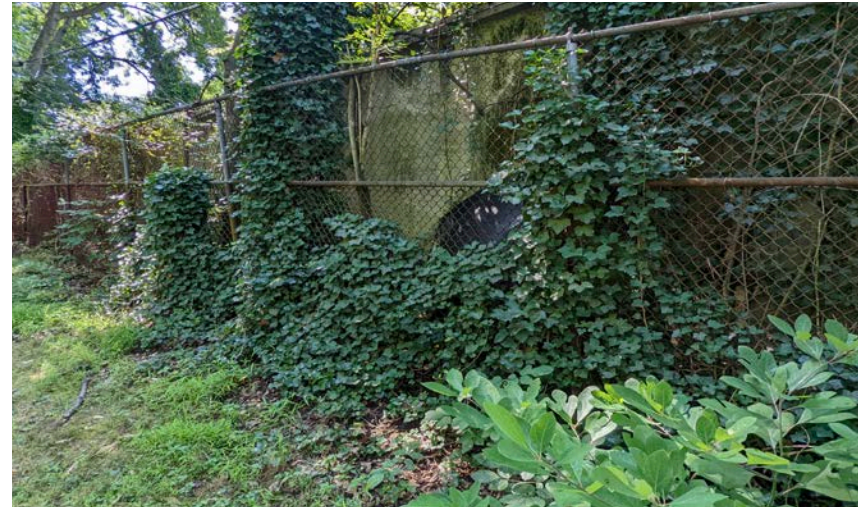
5. Planting Overgrowth at perimeter fencing

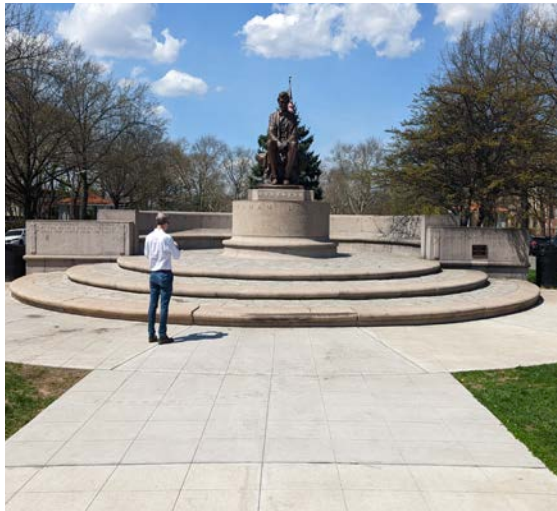
1. General view and setting of “Lincoln the Mystic” statue, including walls, steps, paving, etc.

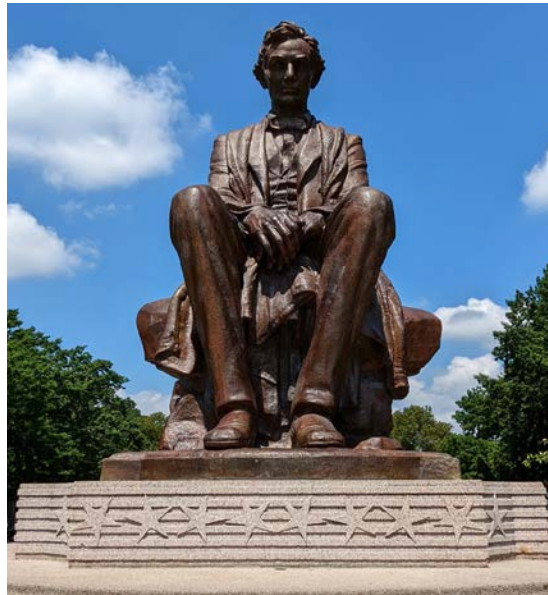
2. “Lincoln the Mystic”

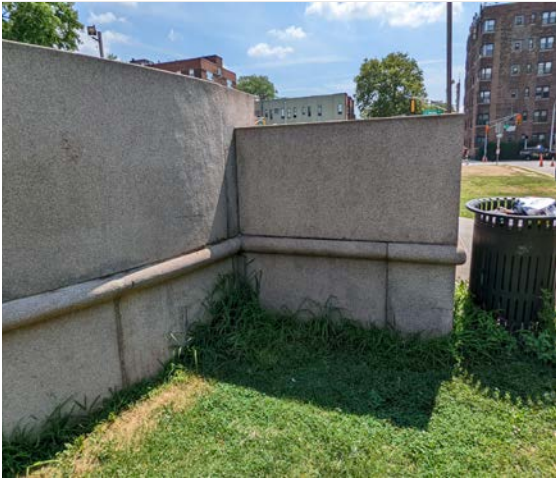
4. Exterior of low wall at rear of statue

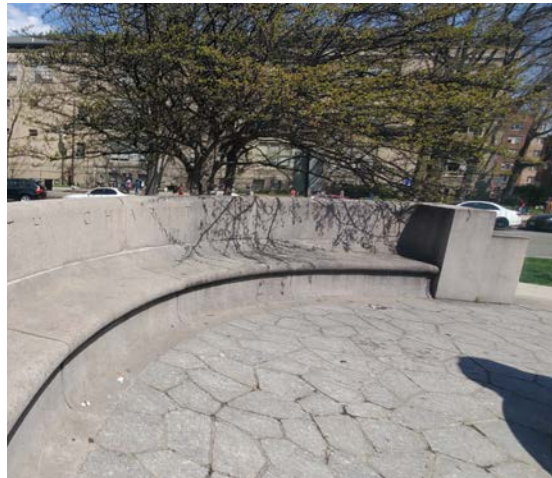
5. Wall, bench and paving behind the statue

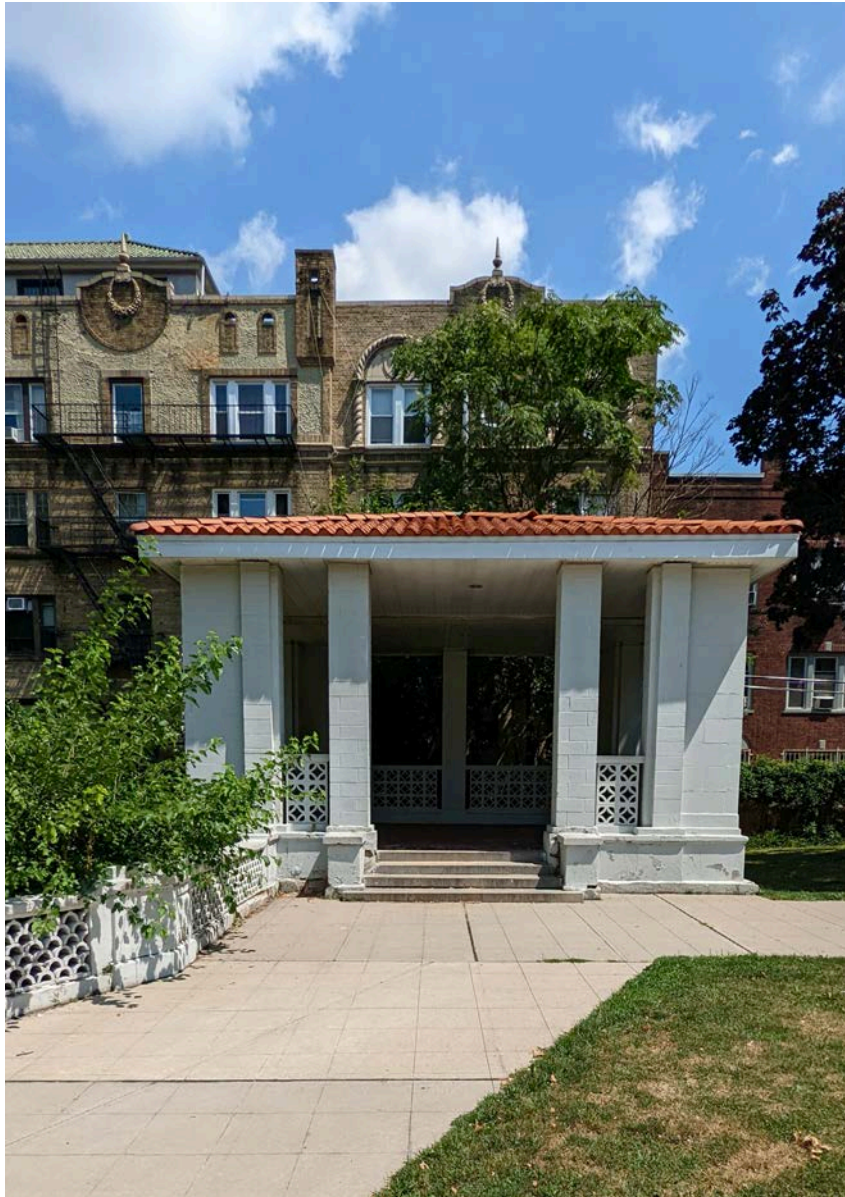
10. South elevation of the North Summer House

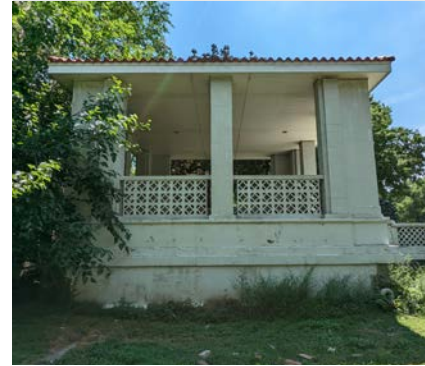
11. West elevation

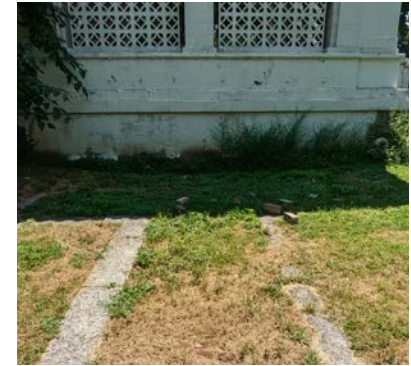
12. Detail of base at west elevation

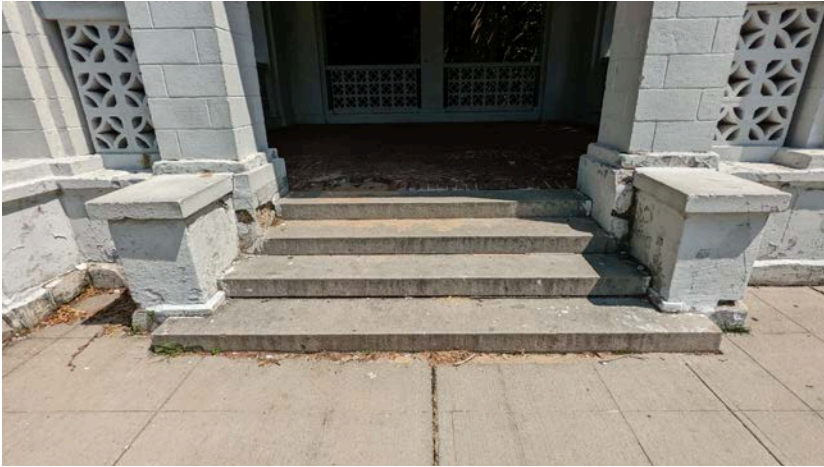
14. South elevation of the North Summer House

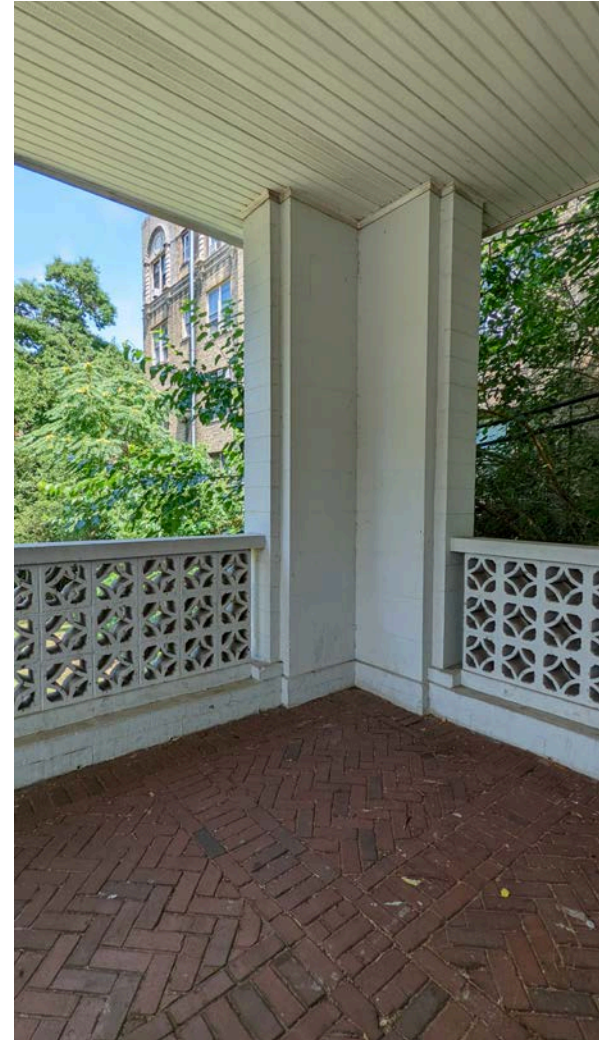
16. CMU corner pier and railings that were constructed in the 1970's renovation

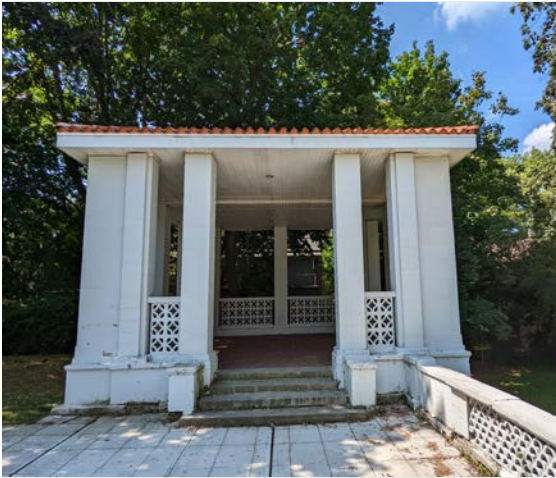
20. North elevation

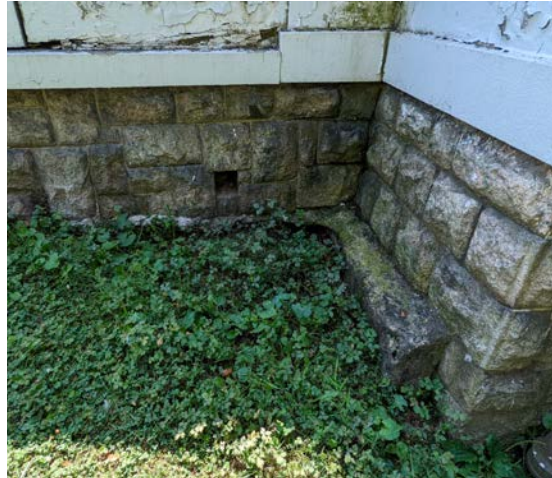
21. Stone base of the Summer House; clear plant growth, clean masonry and repoint as needed

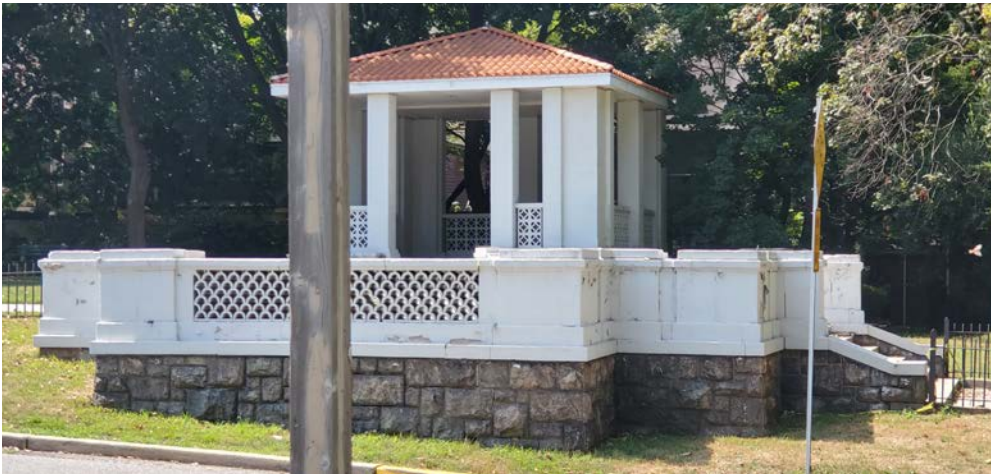
22. General view of the North Summer House with the terraces, railings and steps in foreground

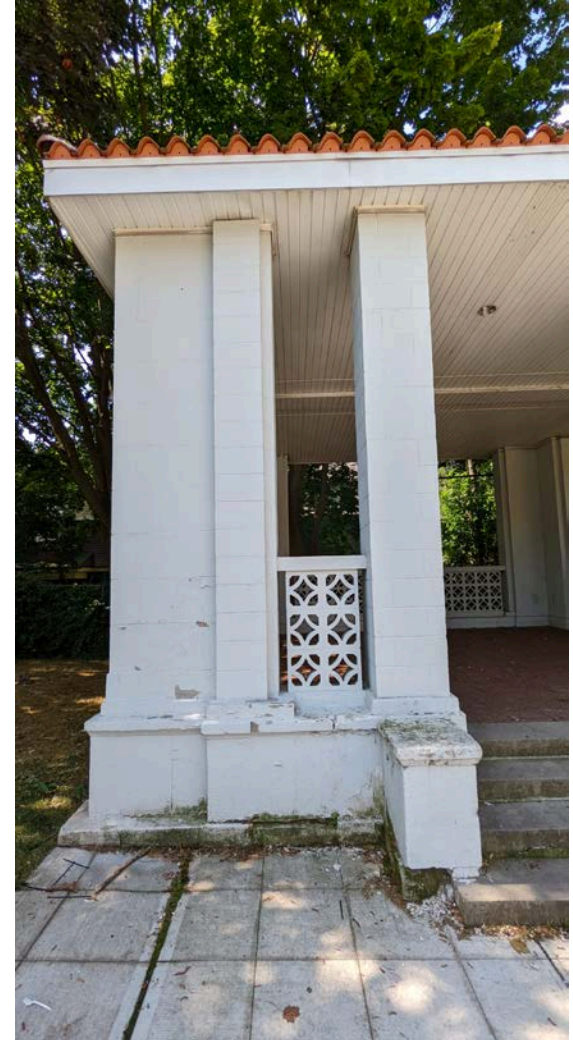
23. Detail of north elevation; piers and railing were altered in the 1970's renovation

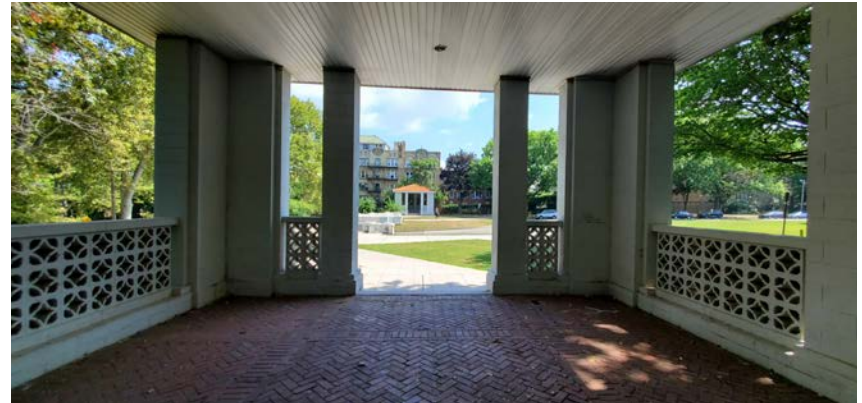
27. General view of interior; piers and railings were replaced and reconfigured in the 1970's

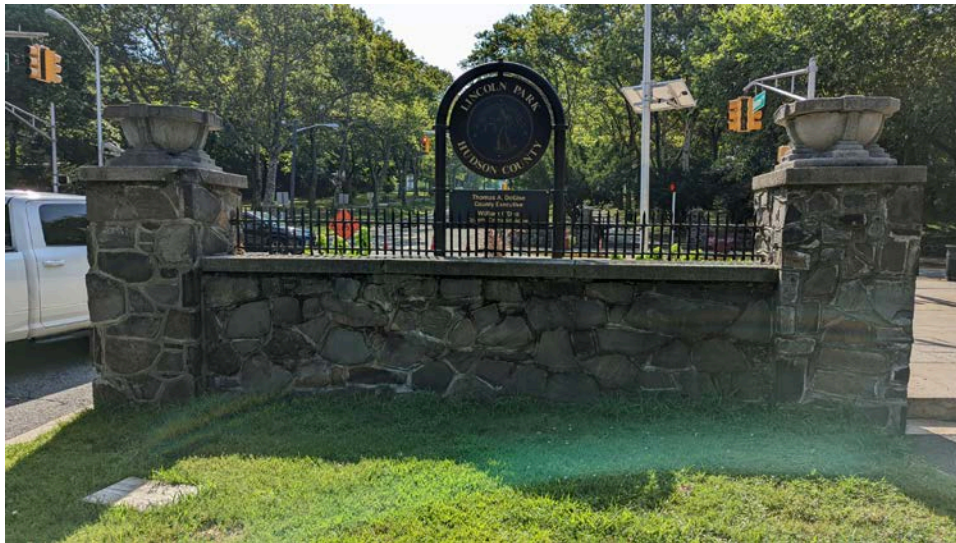
31. General view of the West elevation (view facing east)

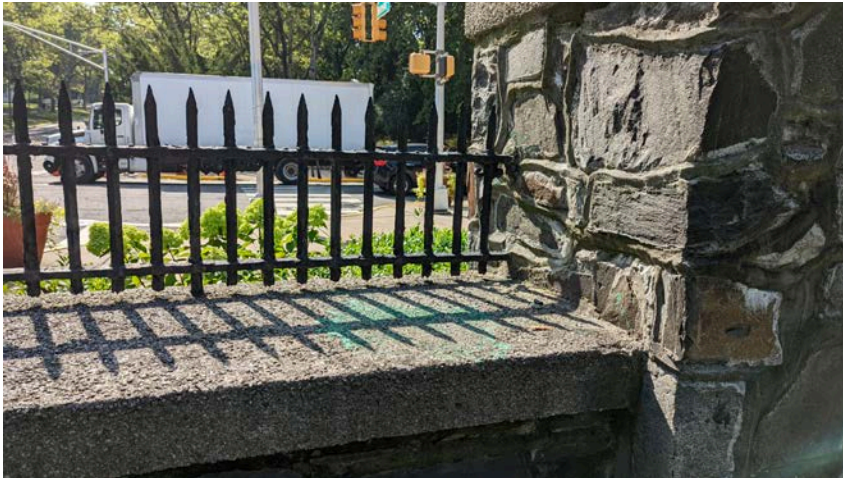
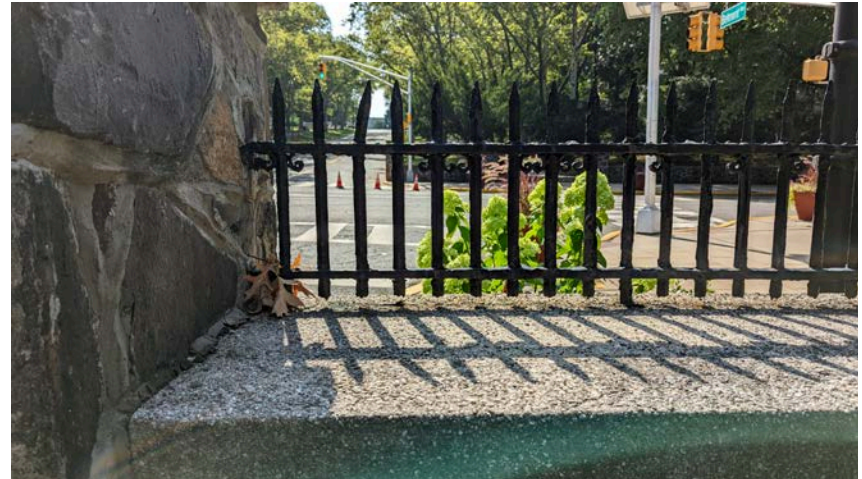
32. Typical detail of wall with cast sone cap and painted stell fencing

5	Site Walls and Piers at West Side Ave Entrance	Some spot pointing needed for general maintenance.	ST	M	MEDIUM	\$84,000
6	Steel Fencing on Walls	Repair, repaint and maintain.	ST	M	HIGH	\$15,000
7	Site Walls and Piers at West Side Ave Entrance	Longer term repairs should include an analysis to determine the original mortar color, mix and configuration. Wholesale repointing should occur per the analysis recommendations.	LT	CP	HIGH	\$30,000
8	Summer House Restoration	Remove all 1970's changes to summer houses. Restore columns, rails, fences to original conditions.	LT	CP	HIGH	\$861,800
9	Cast Stone Urns	Clean, maintain and repair as needed; the exposed aggregate is an important feature; the damaged urn should be replaced. Make sure replacement pieces match the character, including exposed aggregate, of the originals.	MT	CP	HIGH	\$7,500

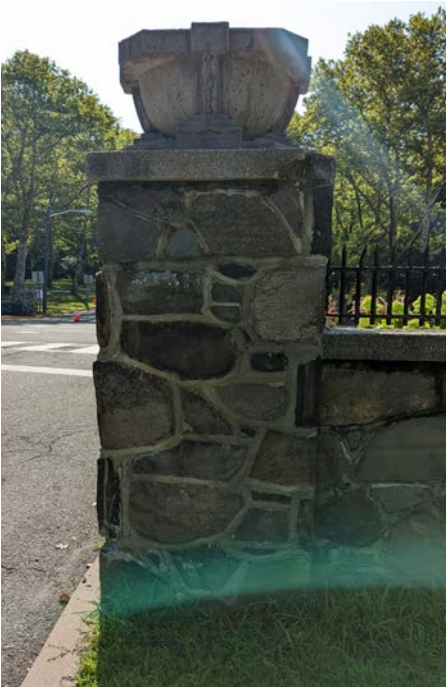
34. Typical pier with cast stone urn

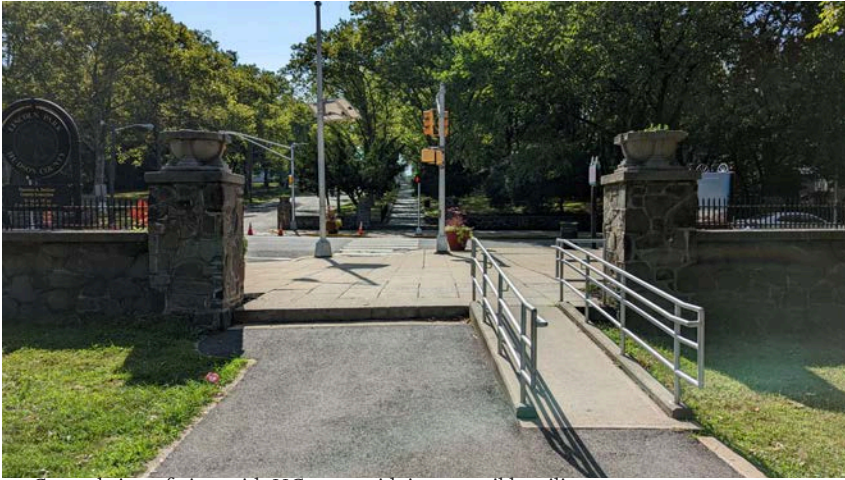
37. General view of piers with HC ramp with incompatible railing

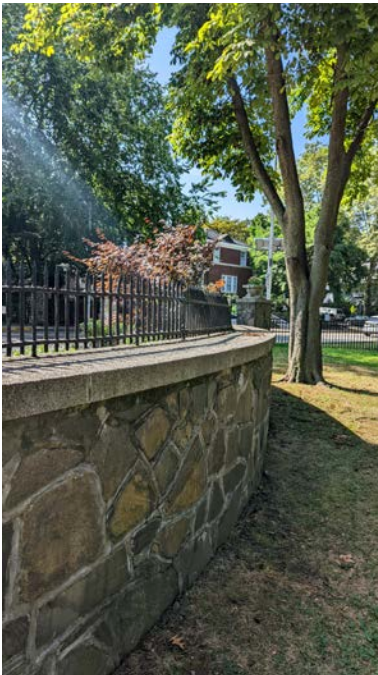
39. Wall with steel railing

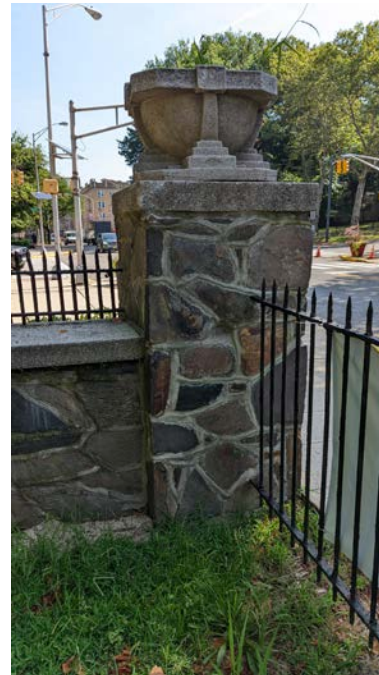
41. Typical pier

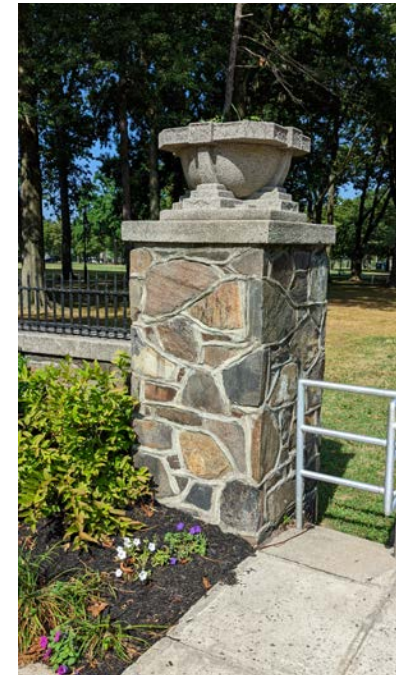
42. Typical pier

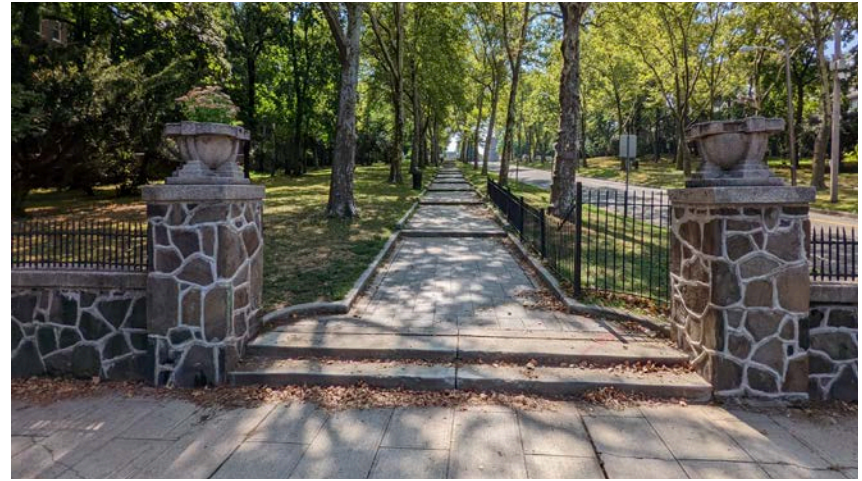
44. Typical piers and wall at Northeast corner of West Side and Belmont Avenues

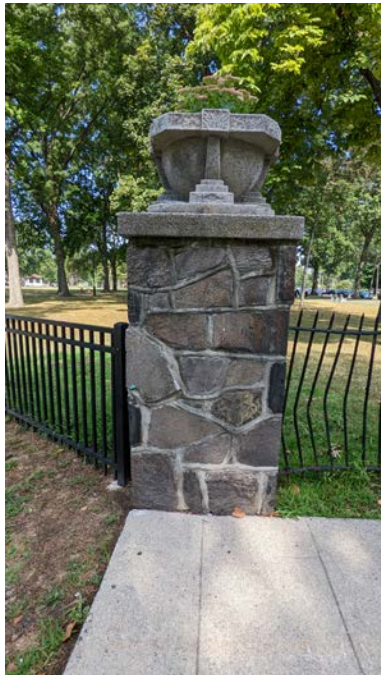
45. Typical pier

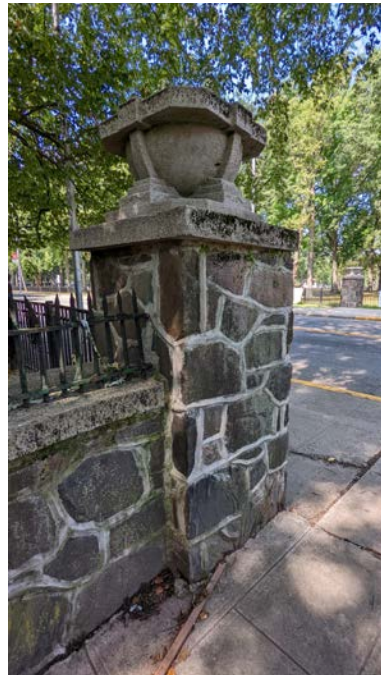
46. Typical pier

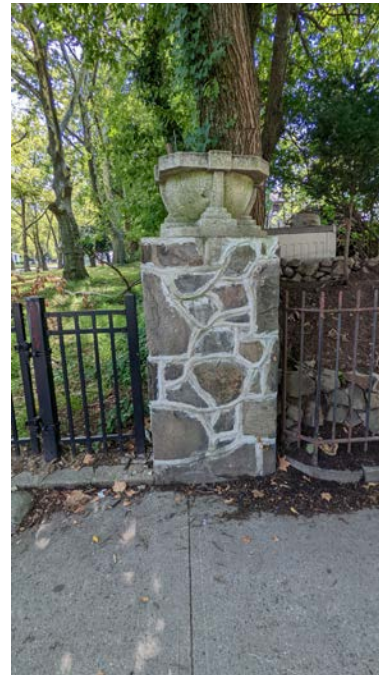
47. Typical pier
